IN THE
Supreme Court of the United States

No. **78-1216**

BRITISH AIRWAYS BOARD,

**PETITION FOR A WRIT OF CERTIORARI TO
THE UNITED STATES COURT OF APPEALS
FOR THE NINTH CIRCUIT**

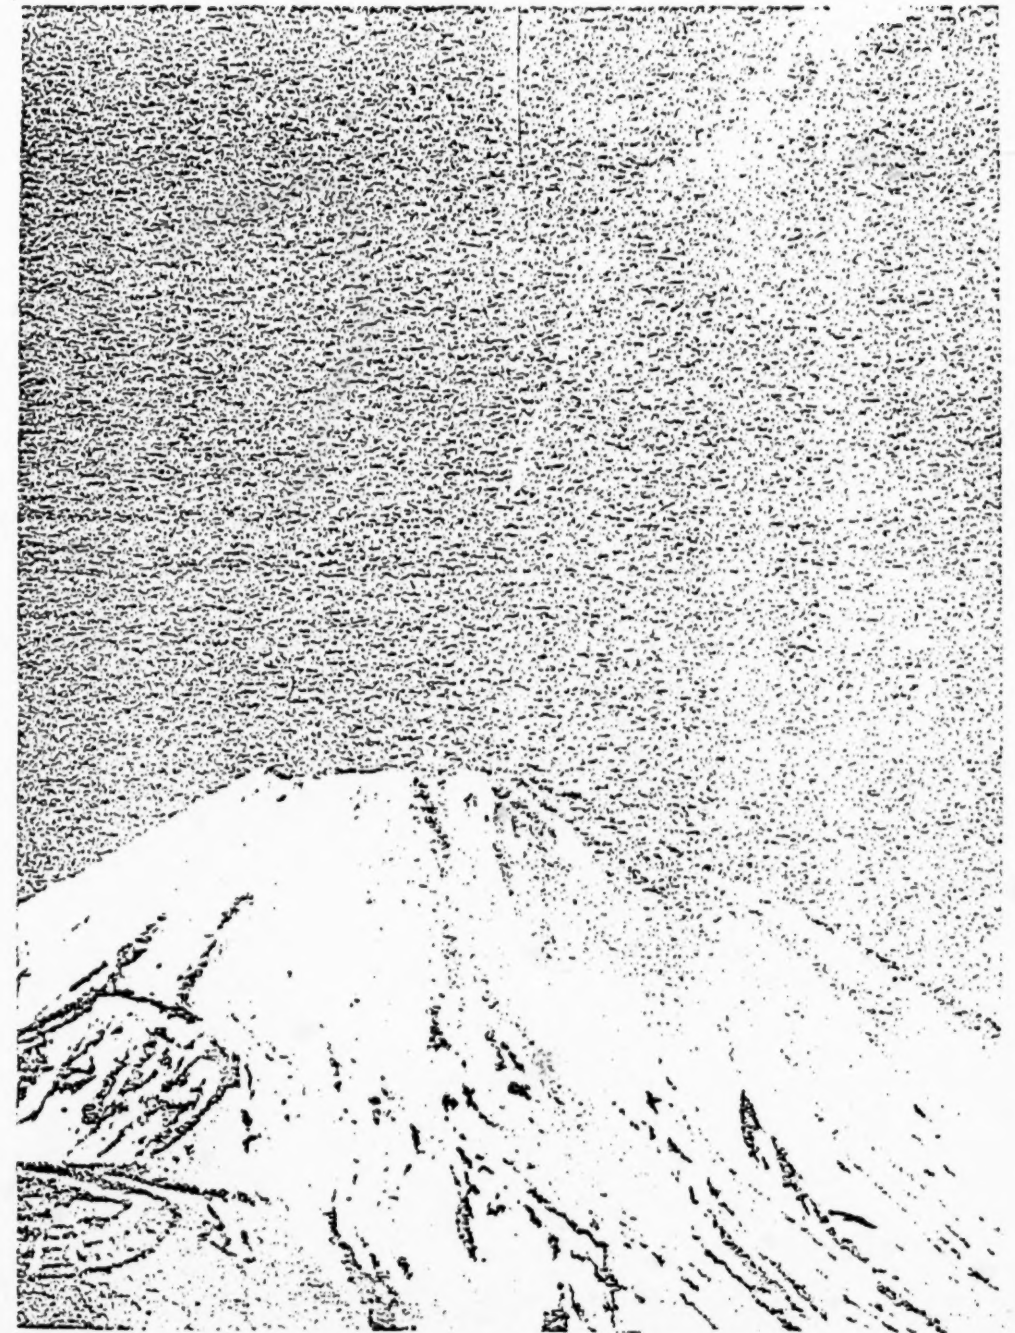
Fig.1 Aircraft descending near Mount Fuji after disintegration

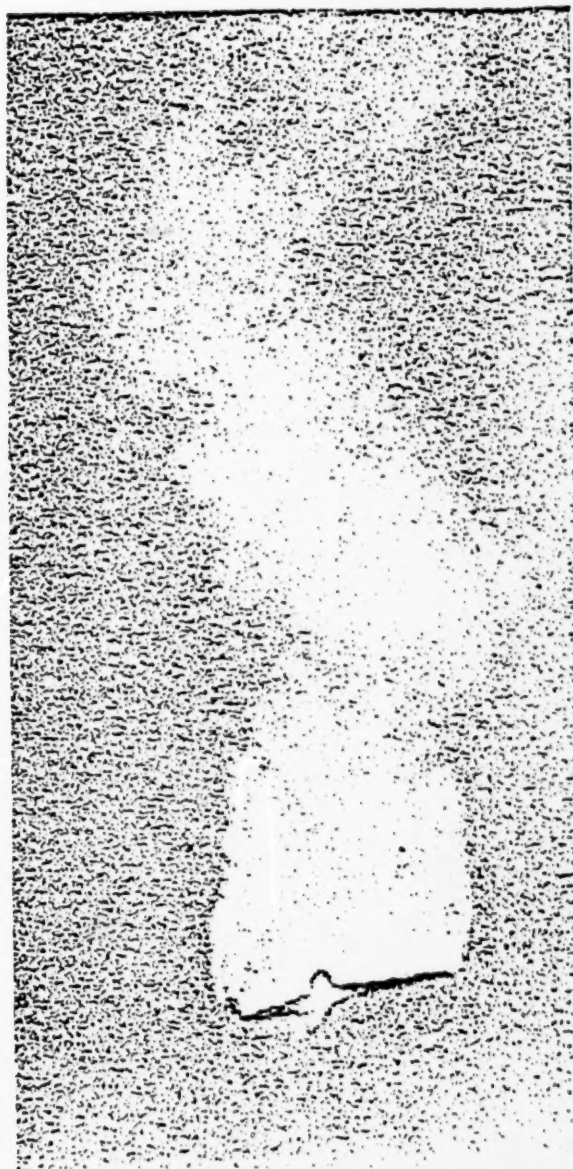
Fig.2 Aircraft spiralling down vertically after detachment of tail unit, engines, forward fuselage and outer starboard wing

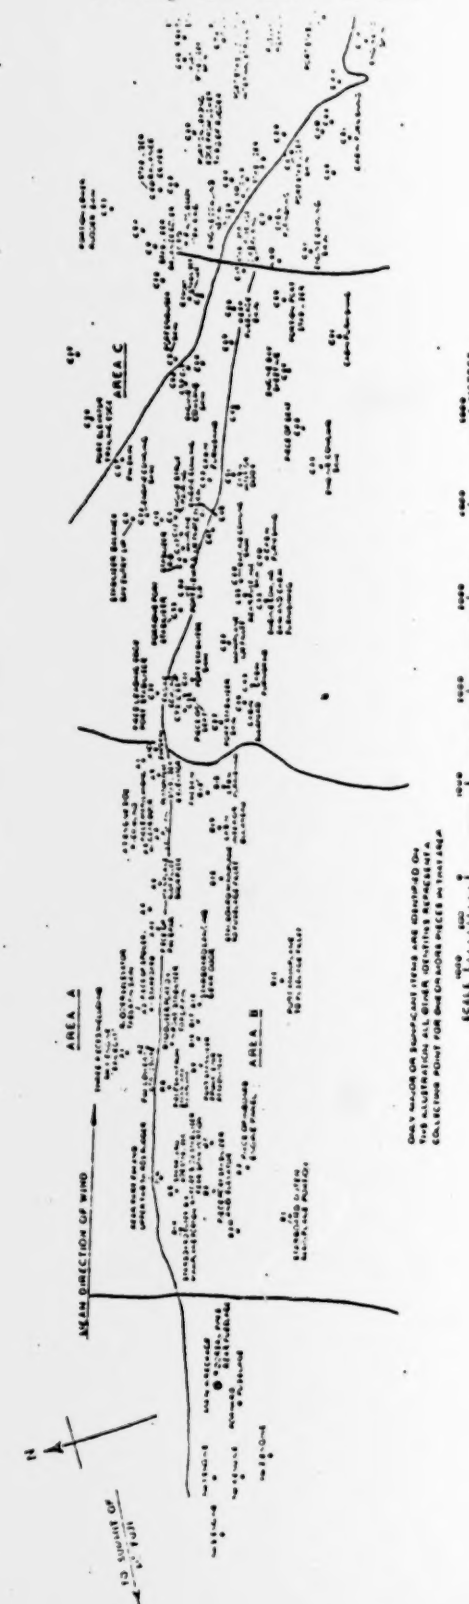
FIG.3 WRECKAGE TRAIL

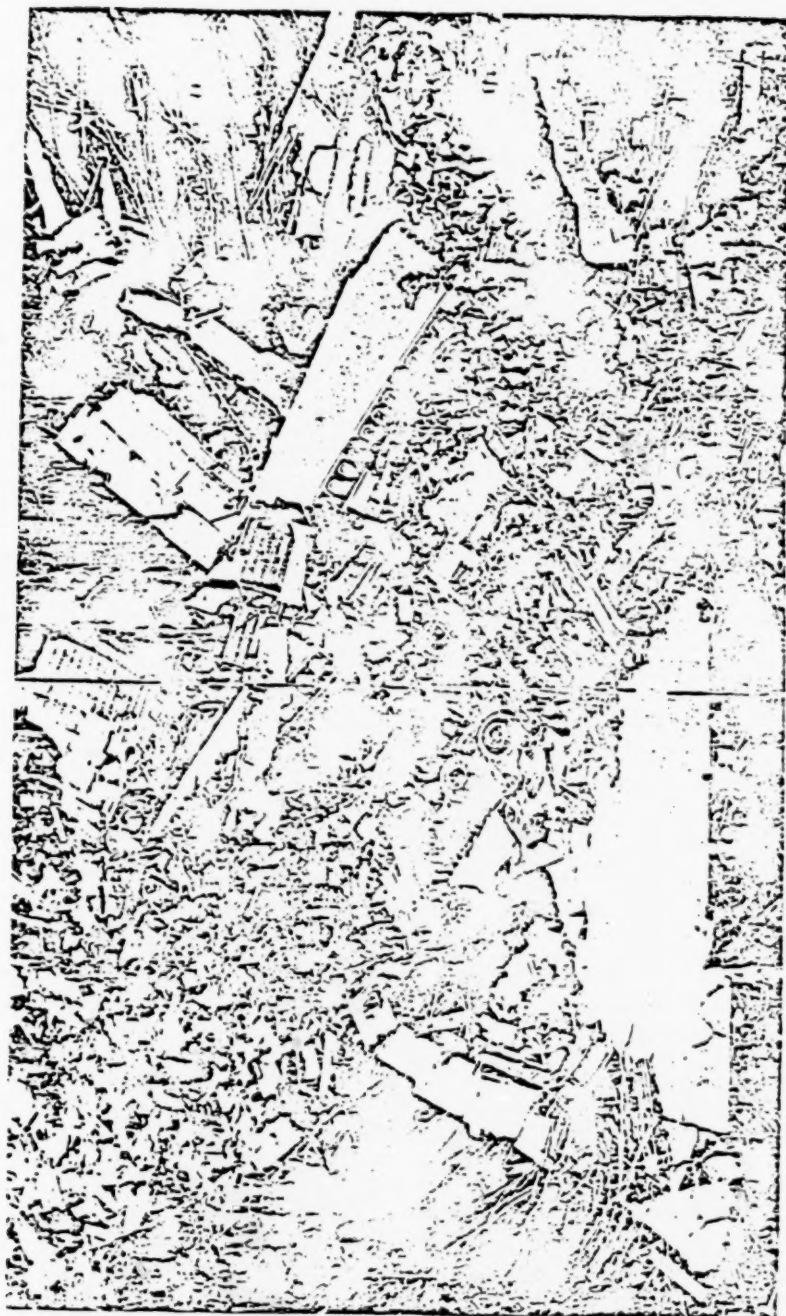
Fig.4 Main wreckage of aircraft

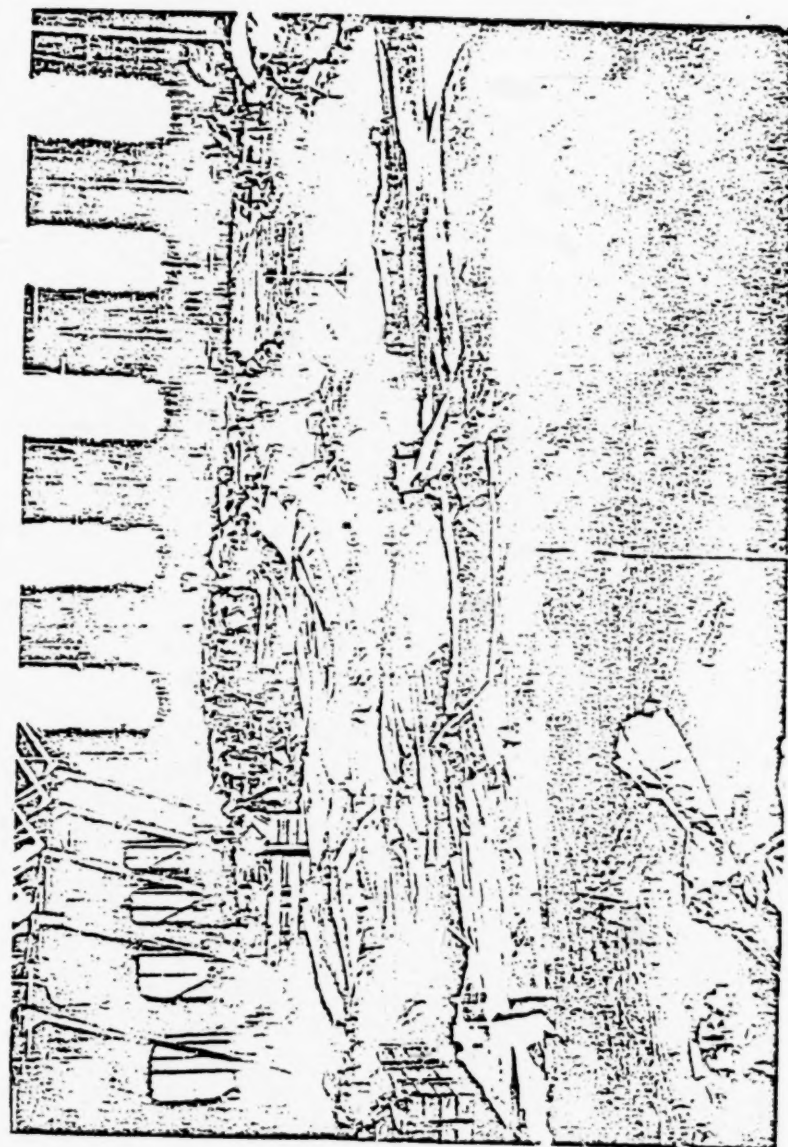
Fig.5 Wreckage assembled at Chofu for examination

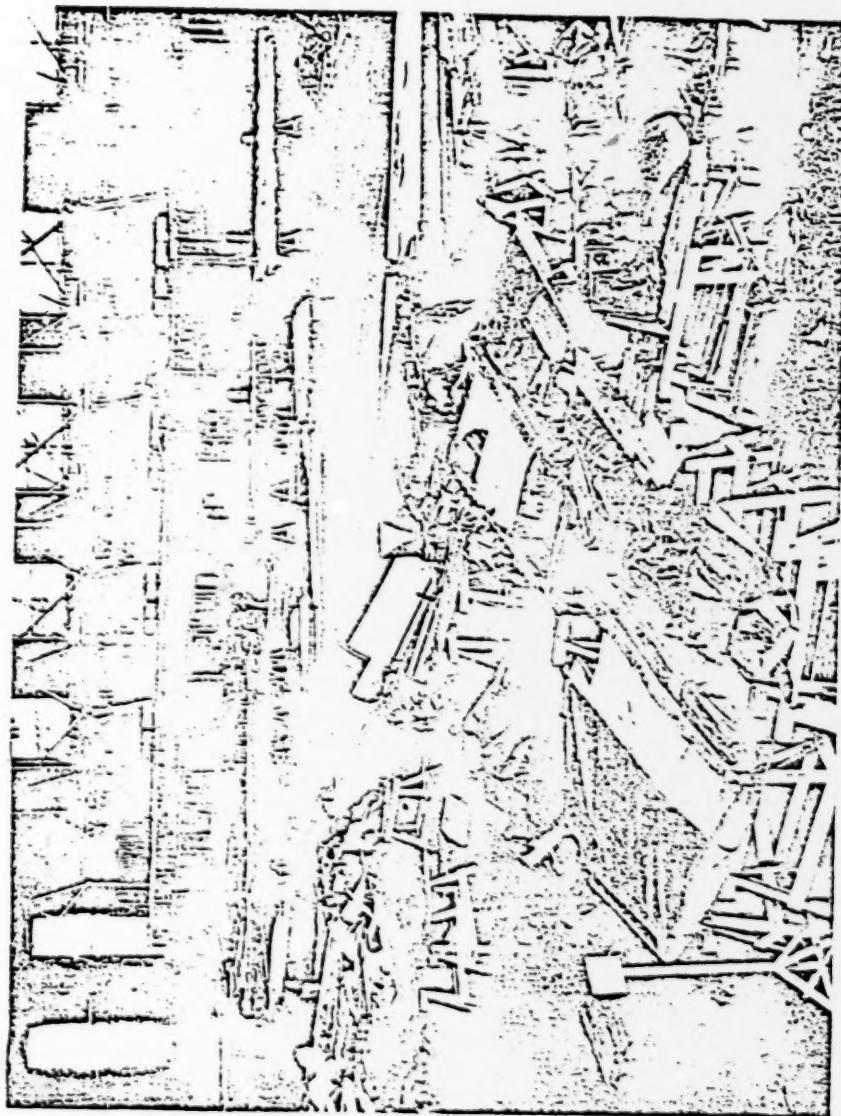
Fig.6 Wreckage assembled at Chofu for examination
(Port horizontal stabilizer and elevator in foreground)

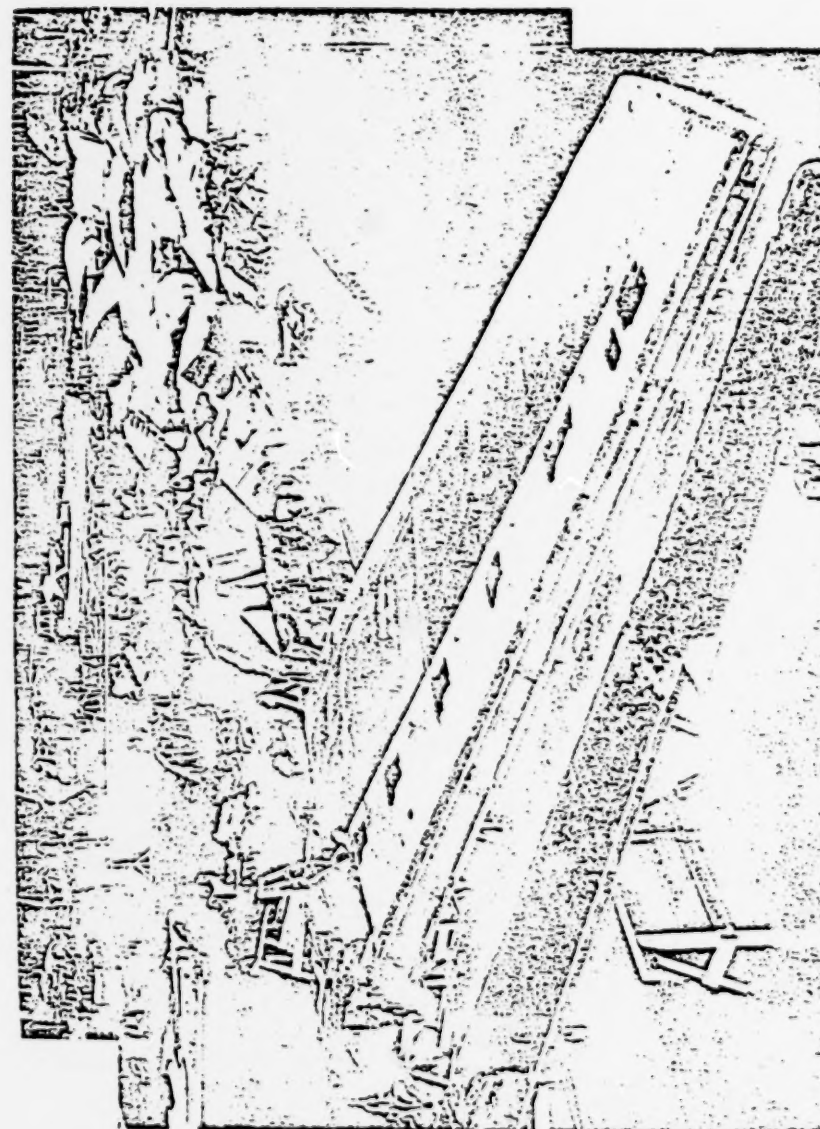
Fig.7 Wreckage assembled at Chofu for examination
(Starboard horizontal stabilizer and elevator in foreground)

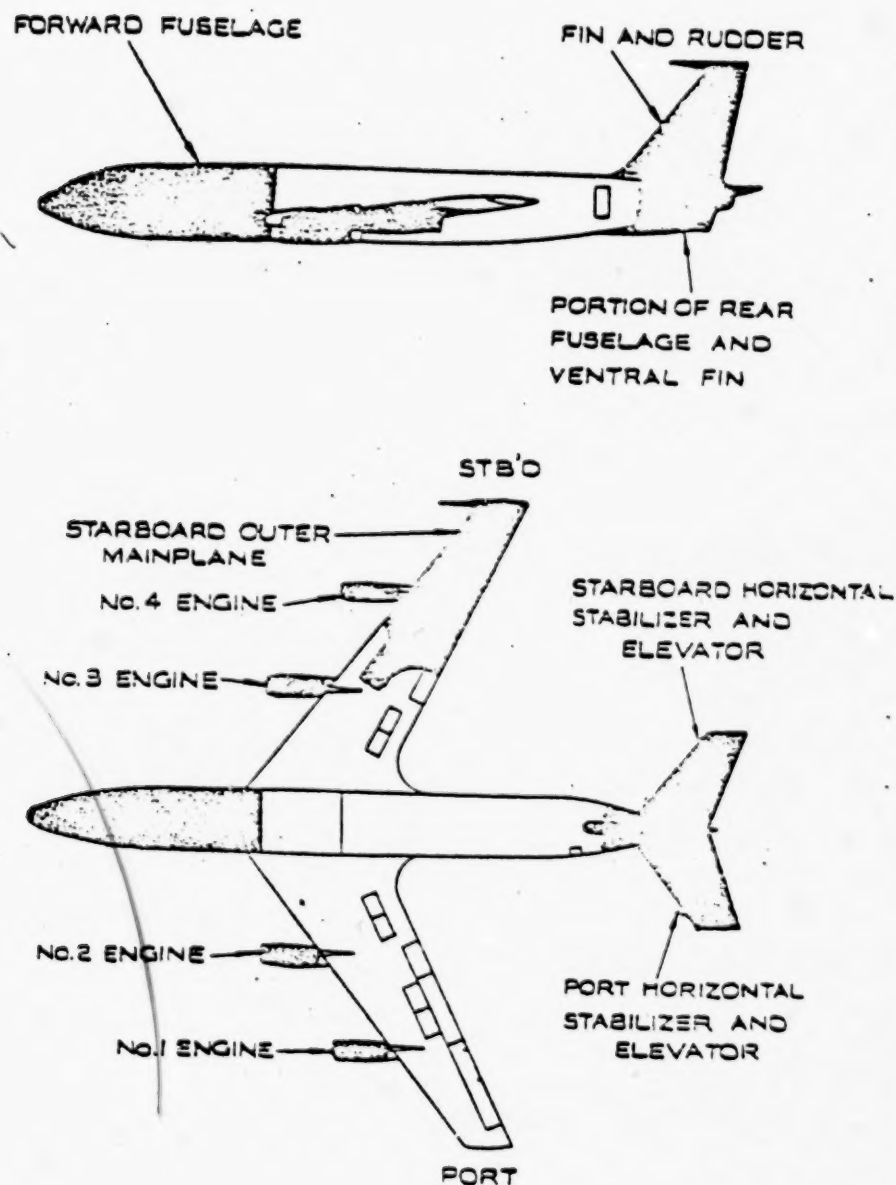
Fig.8

No. 4 ENGINE BECAME DETACHED BY PIVOTING TO PORT ABOUT ITS MOUNTING.

NO EVIDENCE OF MALFUNCTION WAS SEEN ON ANY COMPONENT EXAMINED

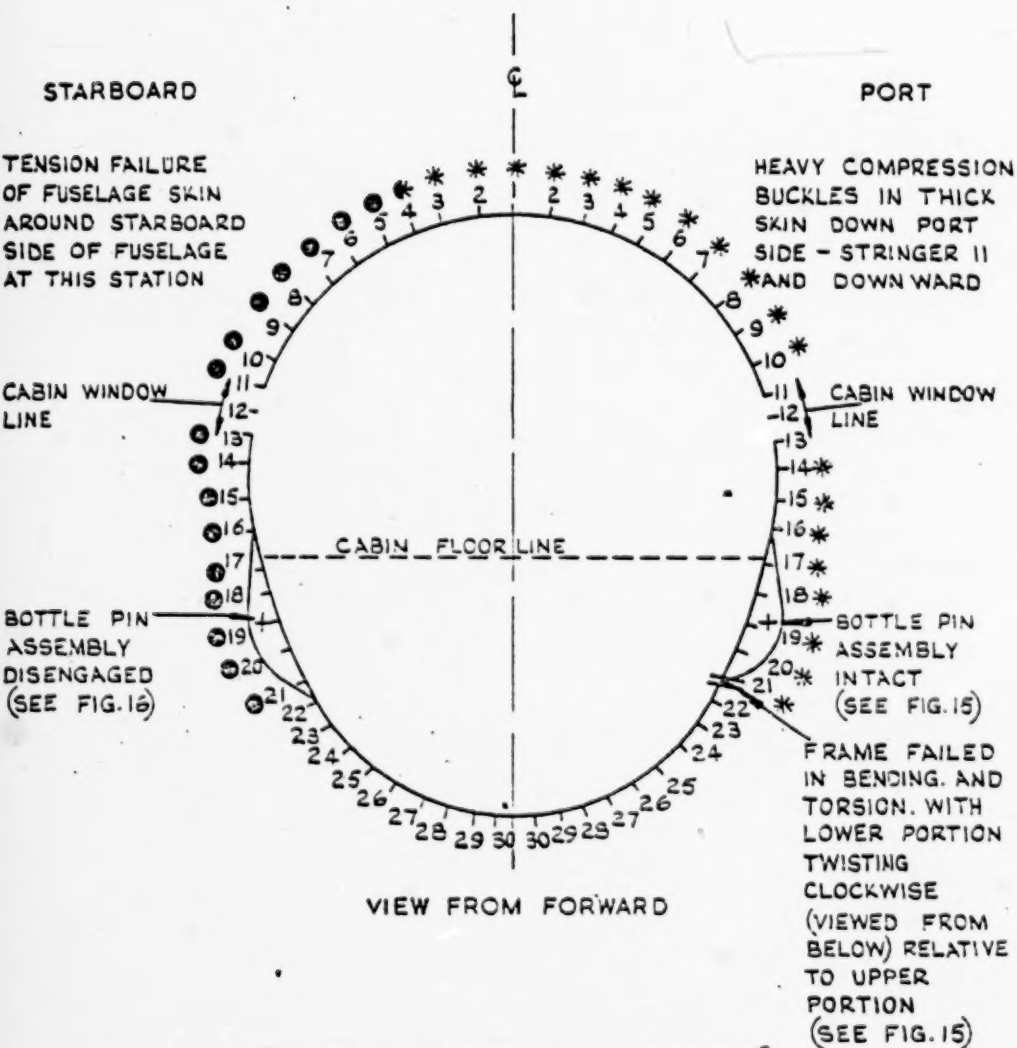
Fig.14

FUSELAGE SKIN AND STRINGER FAILURES
COLLECTIVELY INDICATE BENDING OF
FORWARD FUSELAGE TO PORT, ABOUT STN-600 K.

* STRINGERS FAILED IN COMPRESSION

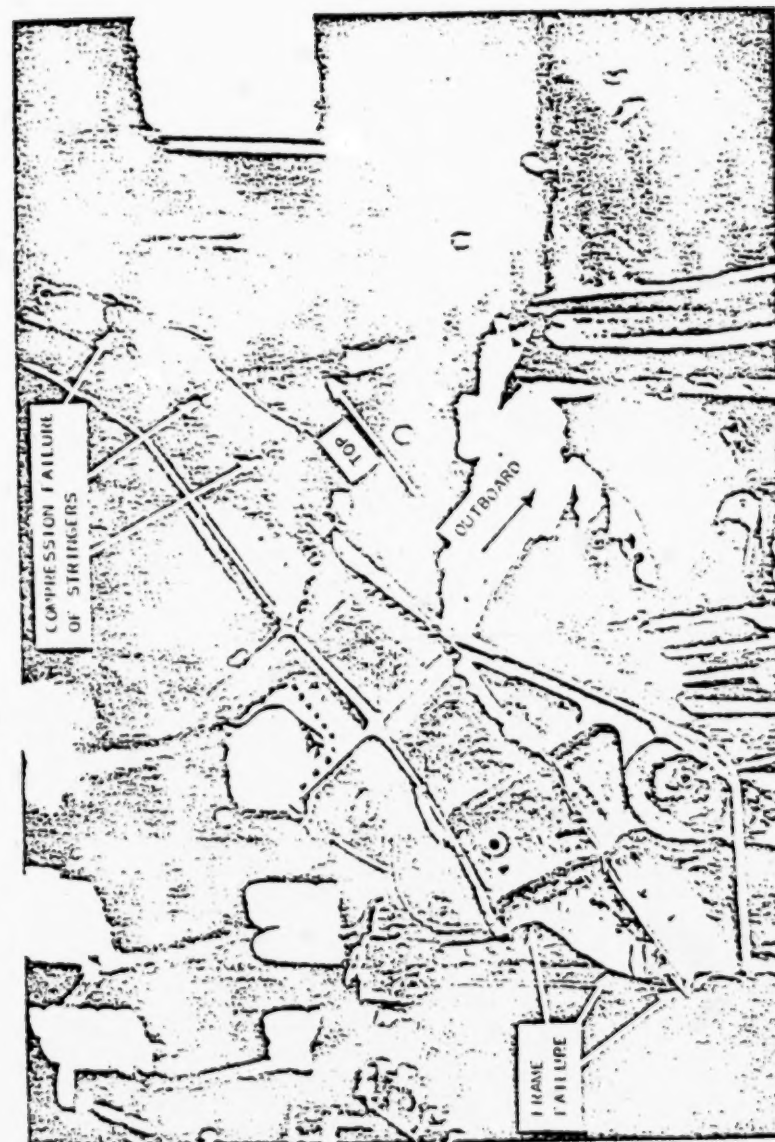
Fig.15

FIG. 15 FUSELAGE SEPARATION ON PORT SIDE OF STN. 600K.

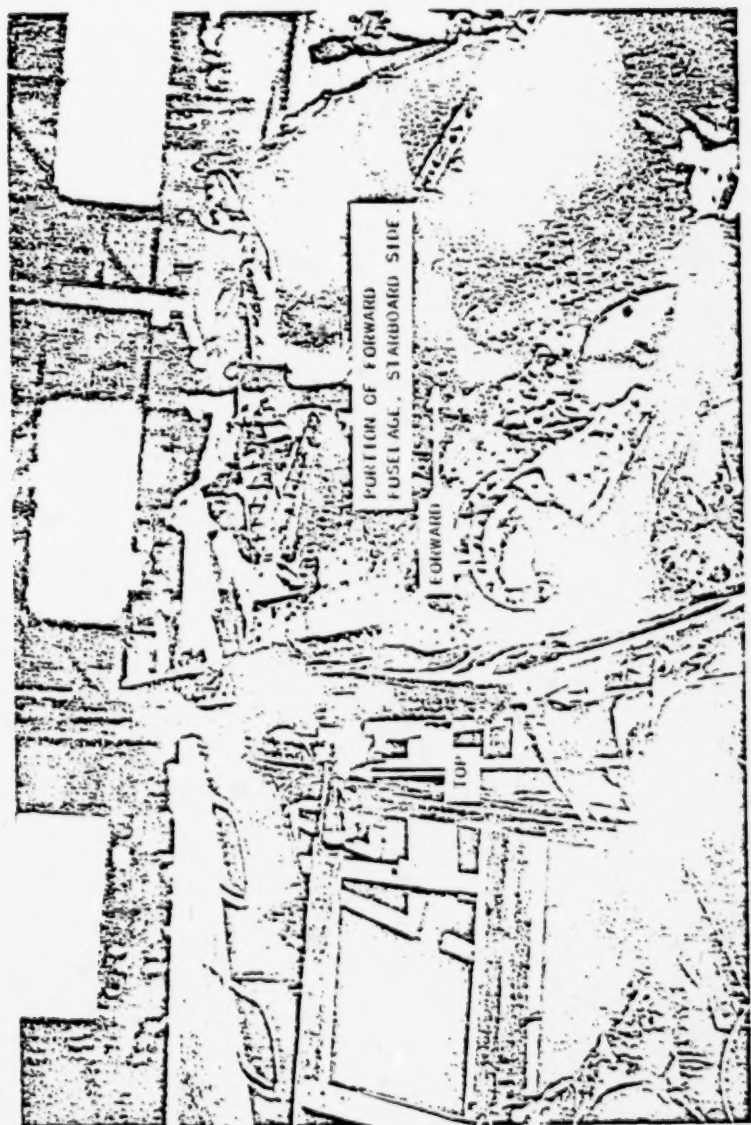
FIG.16 FUSELAGE SEPARATION ON STARBOARD SIDE OF STN. 600K.

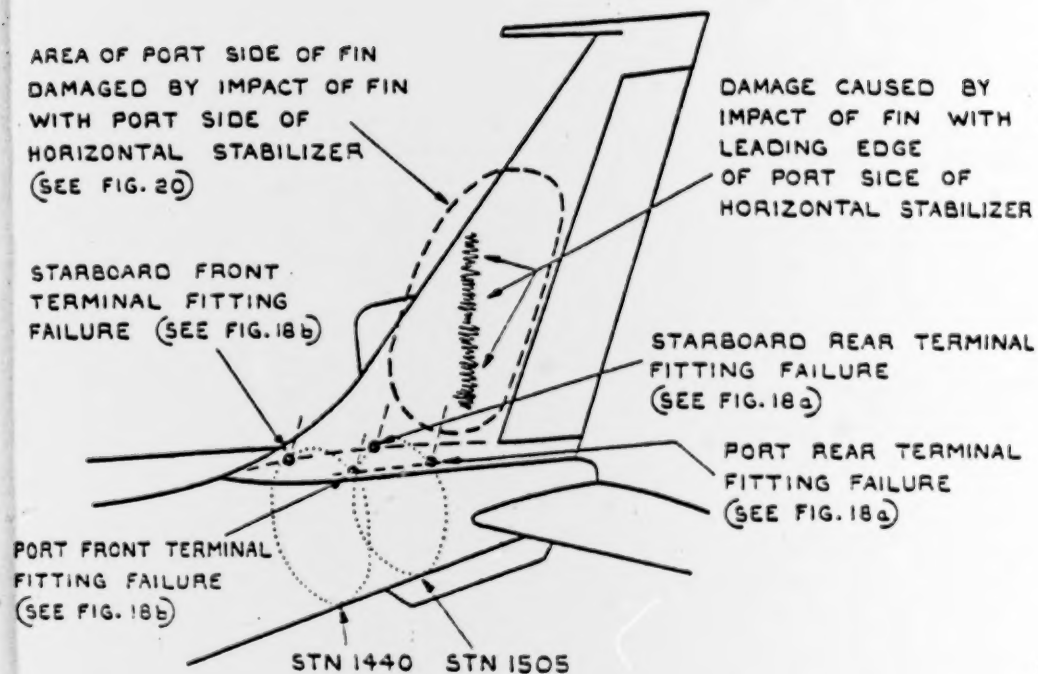
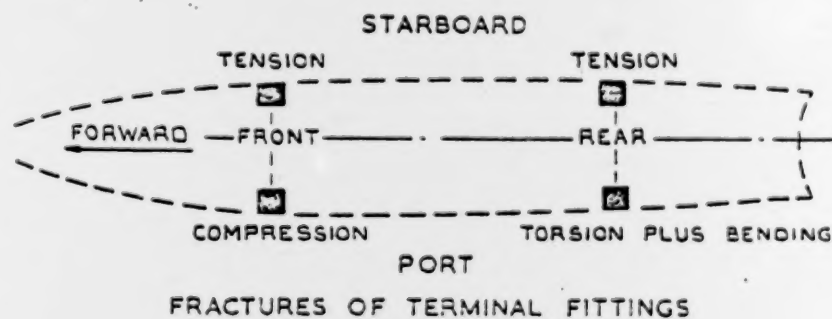
FIG.17 FIN FAILURE

FIN BECAME DETACHED BY BENDING TOP TO PORT.
ABOUT TERMINAL FITTINGS, AND ROTATED DOWNWARDS
TO STRIKE PORT SIDE OF HORIZONTAL STABILIZER.

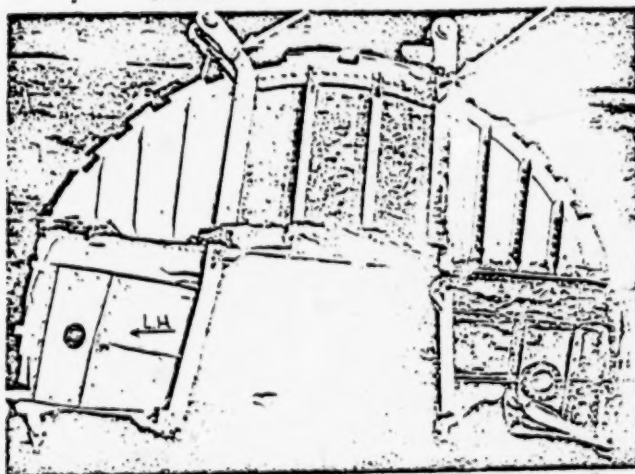
FIG.18(A)

PORT FITTING FRACTURE (TORSION AND BENDING) STARBOARD FITTING FRACTURE (TENSION)

FRACTURED TERMINAL FITTINGS POSITIONED ON BULKHEAD 1505, VIEW FROM REAR

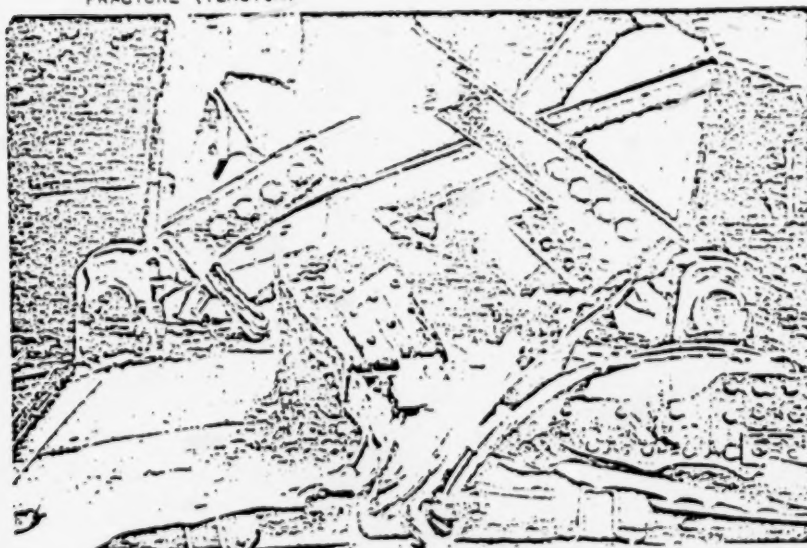
FIG.18(B)

STARBOARD FITTING FRACTURE (TENSION)

PORT FITTING FAILURE (COMPRESSION)

FRACTURED FRONT TERMINAL FITTINGS, VIEW FROM FORWARD

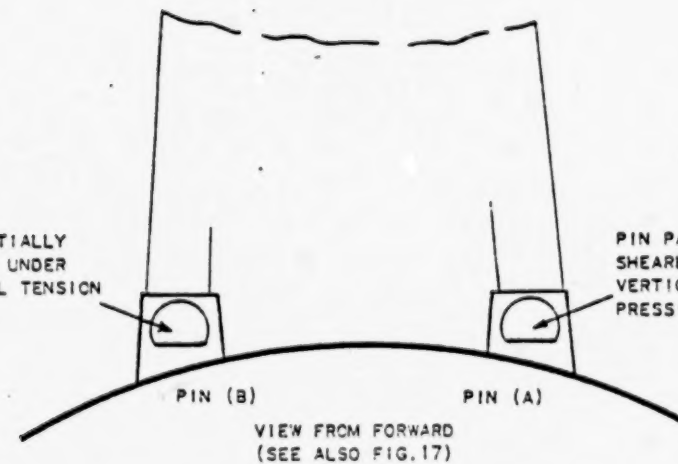
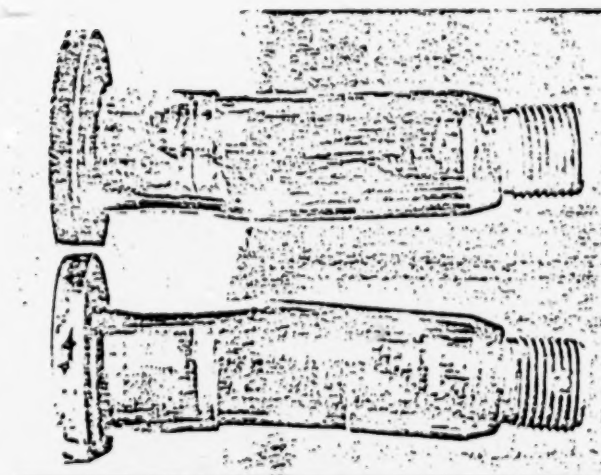
FIG.19. FRONT TERMINAL FITTINGS - ATTACHMENT PINS IN FIN

PIN PARTIALLY SHEARED UNDER VERTICAL TENSION LOADS

PIN PARTIALLY SHEARED UNDER VERTICAL COMPRESSION LOADS

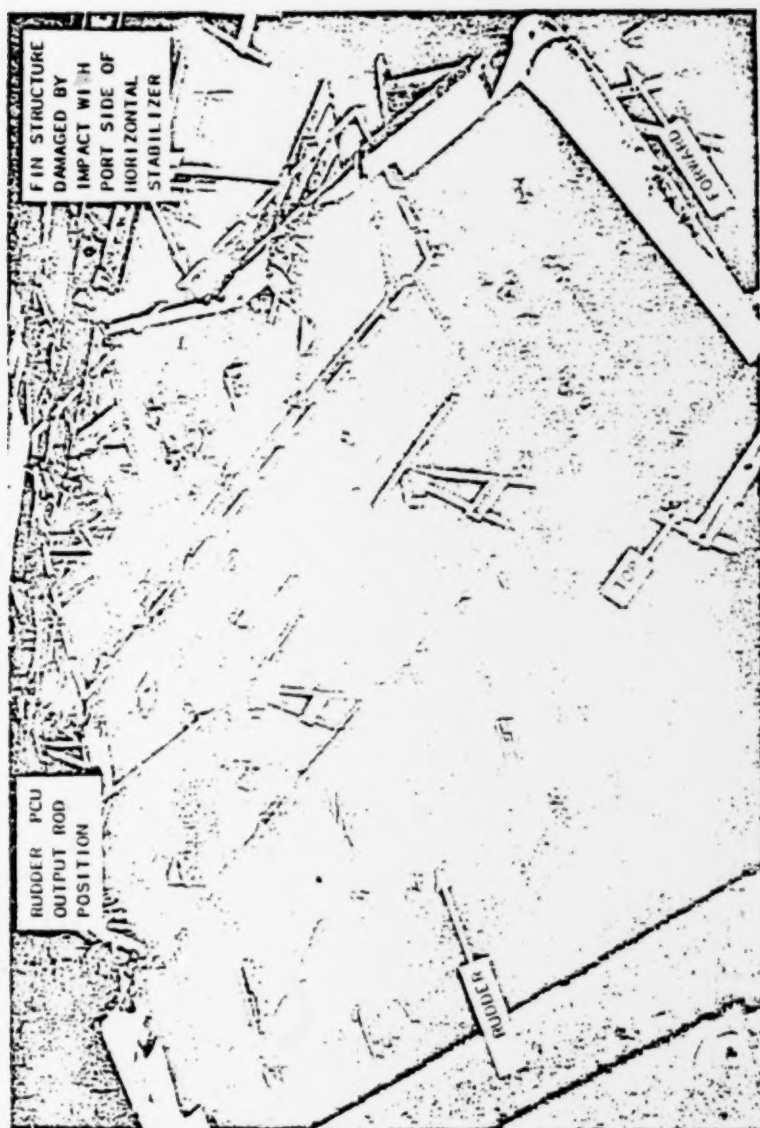
FIG.20. FIN AND RUDDER WRECKAGE

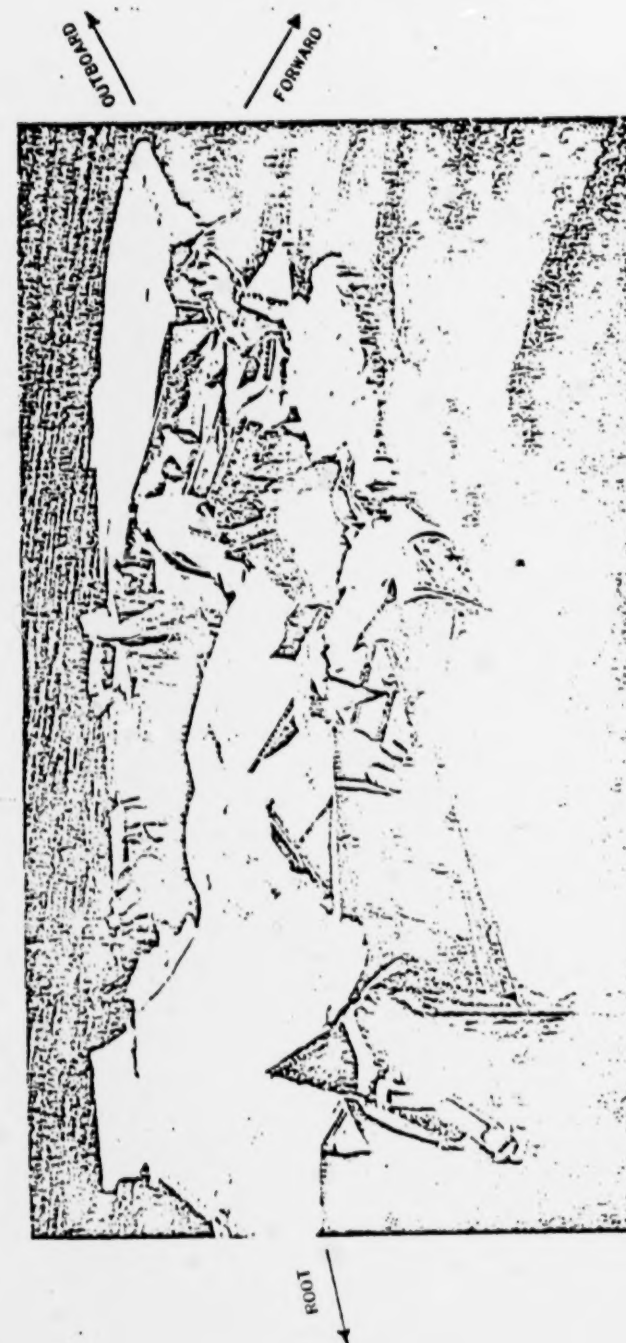
PARTIAL RECONSTRUCTION, SHOWING CENTRAL PORTION DISRUPTION FOLLOWING IMPACT BY FIN

FIG.21. PORT SIDE OF HORIZONTAL STABILIZER

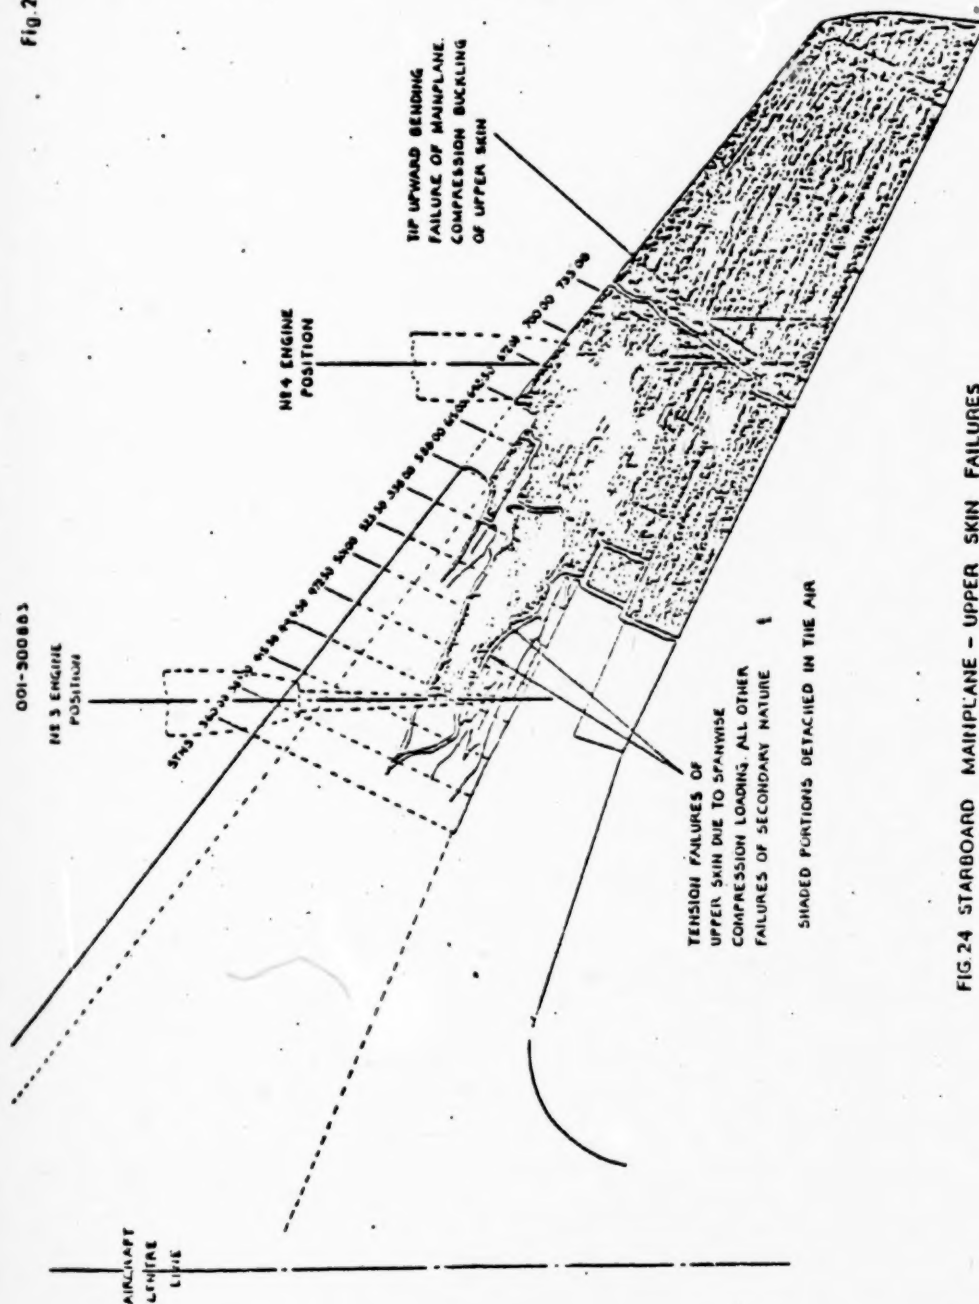
Fig. 24

FIG 24 STARBOARD MAINPLANE - UPPER SKIN FAILURES

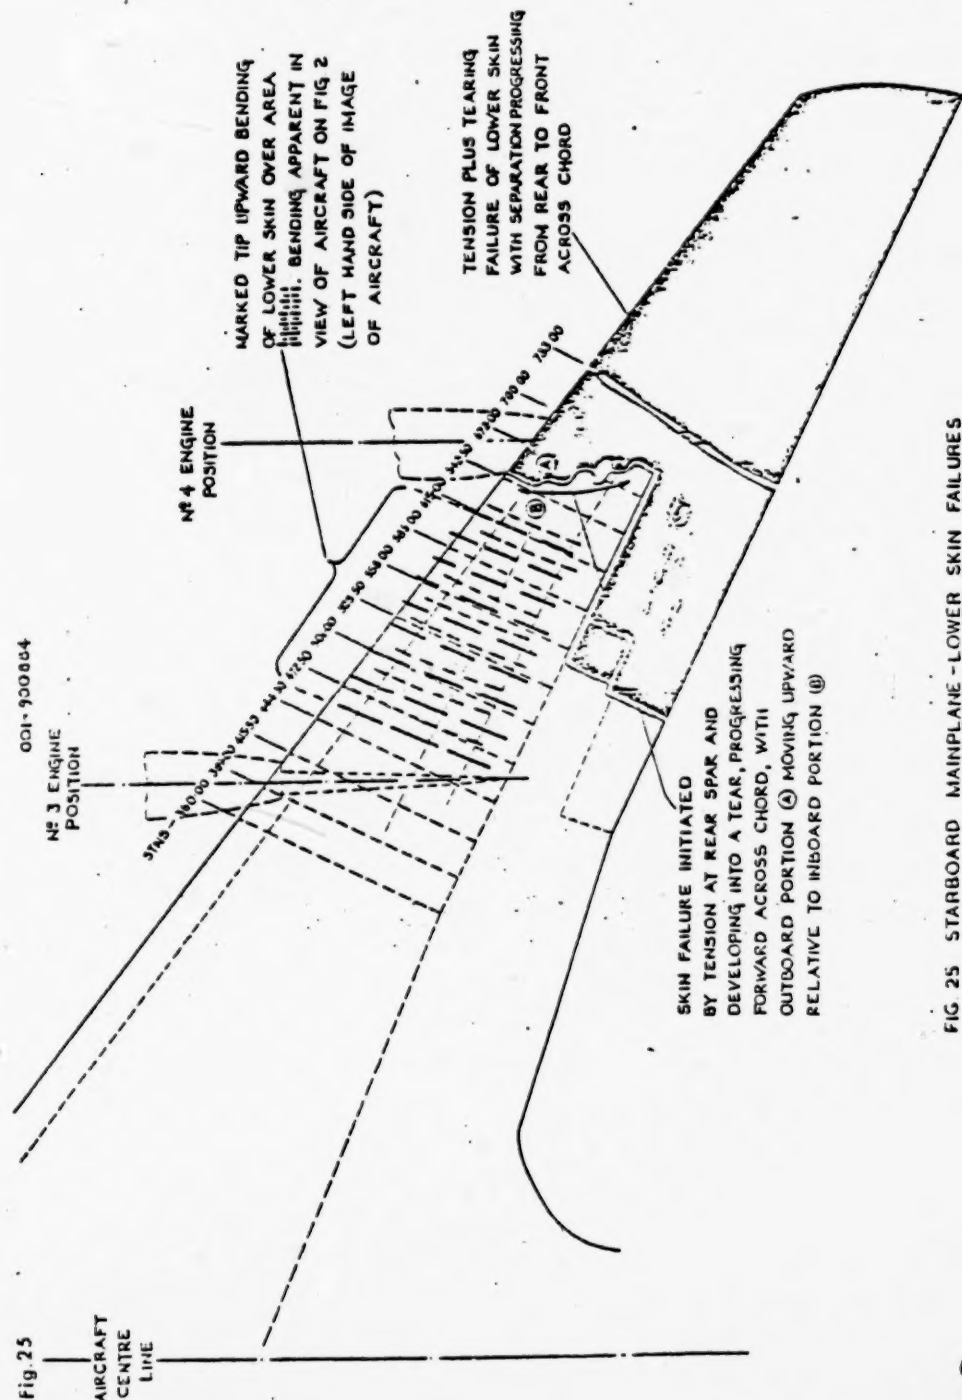
Fig 25

FIG 25 STARBOARD MAINPLANE - LOWER SKIN FAILURES (VIEWED FROM ABOVE)
